Turtle Lake Land Use Survey, July 2004

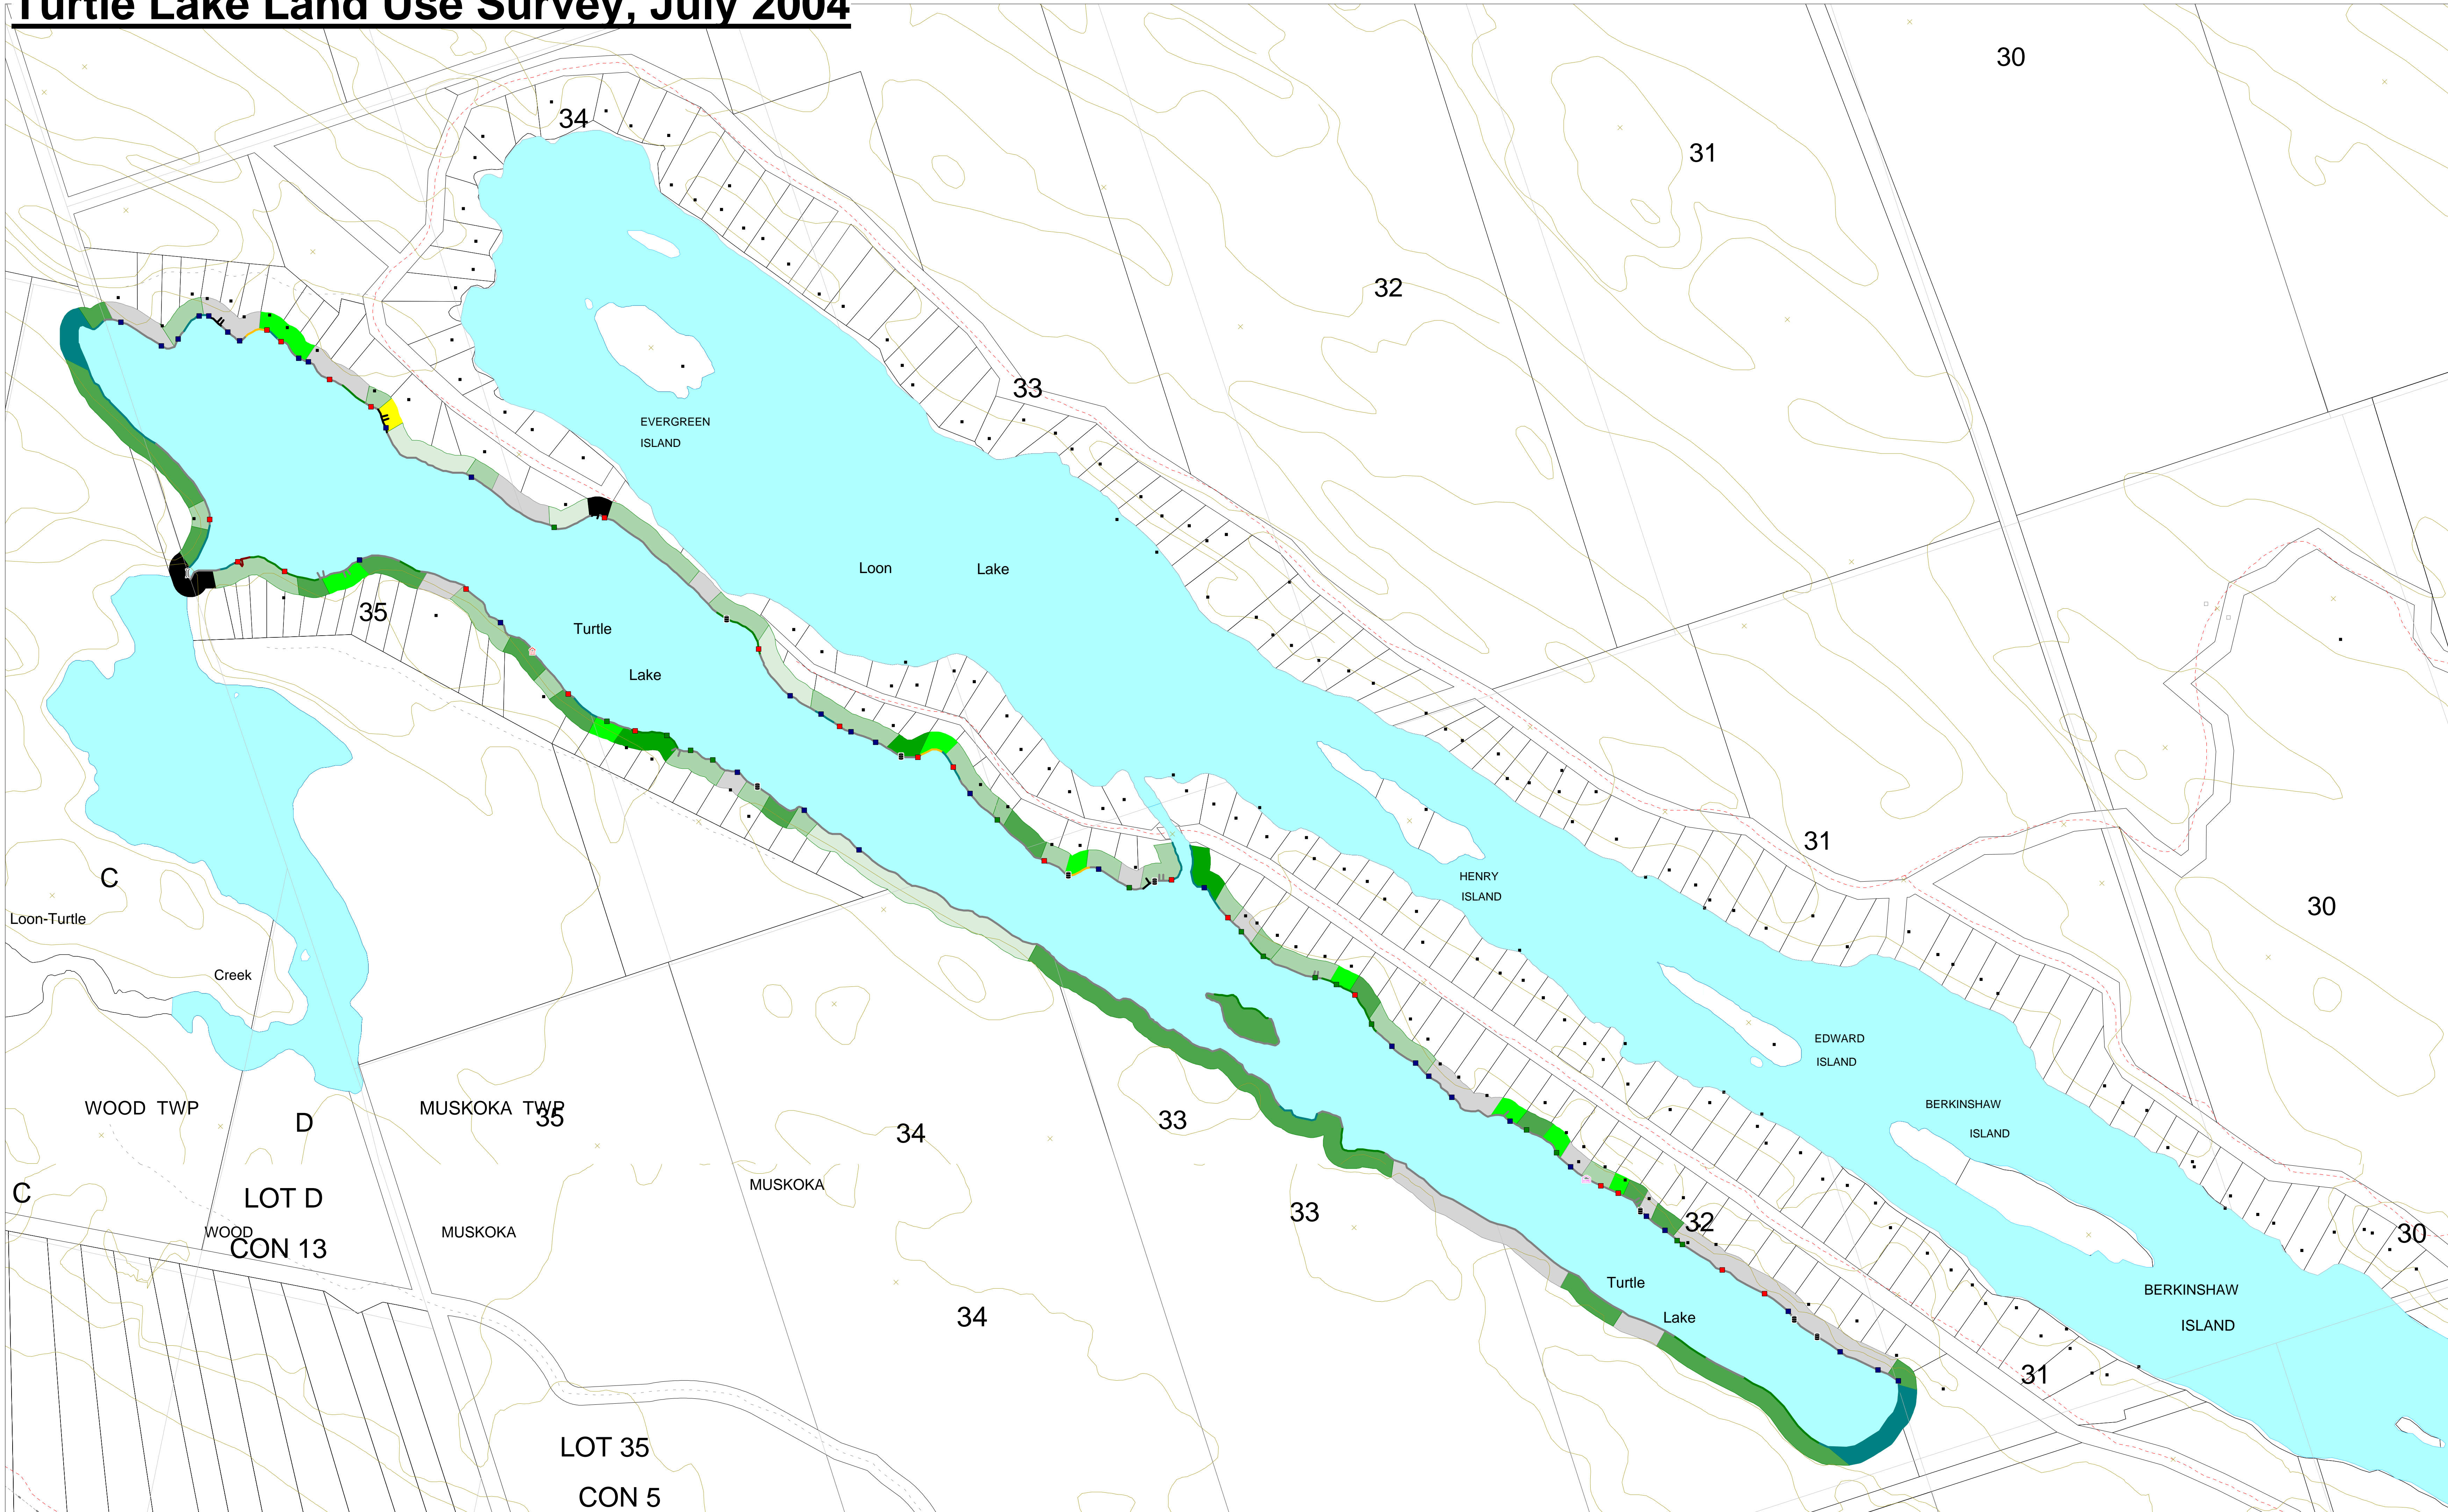
Structure	Type	Count
DC	Crib Dock	23
DFL	Floating Dock	35
DP	Pillar Dock	16
OSB	Bridge	1
OSD	Deck	8
OSSC	Sleep Cabin	1
	Total	85

Backlot	Type	Area_m2	Percent
NFM	Mixed Forest	34,178.81	30.81
NFT	Thinned Forest	24,755.96	22.32
NO	Overgrowth	991.44	0.89
NRB	Barren Rock	23,961.74	21.60
NW	Wetland	3,833.00	3.46
OMMB	Man Made Beach	589.57	0.53
OR	Road	1,976.37	1.78
YLB	Buffered Lawn	3,447.13	3.11
YLU	Unbuffered Lawn	6,304.06	5.68
	Total	110,924.86	100.00
	Natural	72,860.33	65.68
	Altered	38,064.53	34.32

Shoreline	Type	Length_m	Percent
NB	Beach	74.68	1.32
NR	Rock	3,918.17	69.17
NS	Shrub	702.22	12.40
NW	Wetland	758.67	13.39
RC	Concrete Ramp	10.55	0.19
SWC	Cement Shorewall	56.13	0.99
SWS	Stone Shorewall	124.93	2.21
SWW	Wood Shorewall	19.57	0.35
	Total	5,664.92	100.00
	Natural	5,453.74	96.27
	Altered	211.18	3.73
	Structures	436.00	7.70
